Monthly Oversight Report 59  
44728 AES [46526 RAC]  
ACS NPL Site  
Griffith, Indiana  
November 5, 2005 – December 2, 2005

Subject: Monthly Oversight Summary Report  
No. 59 for November 2005

**Monthly Oversight Summary Report No. 59**  
**ACS Superfund Site**  
**TO 057, 44728.238 (AES) [WA57, 46526.238 (RAC)]**

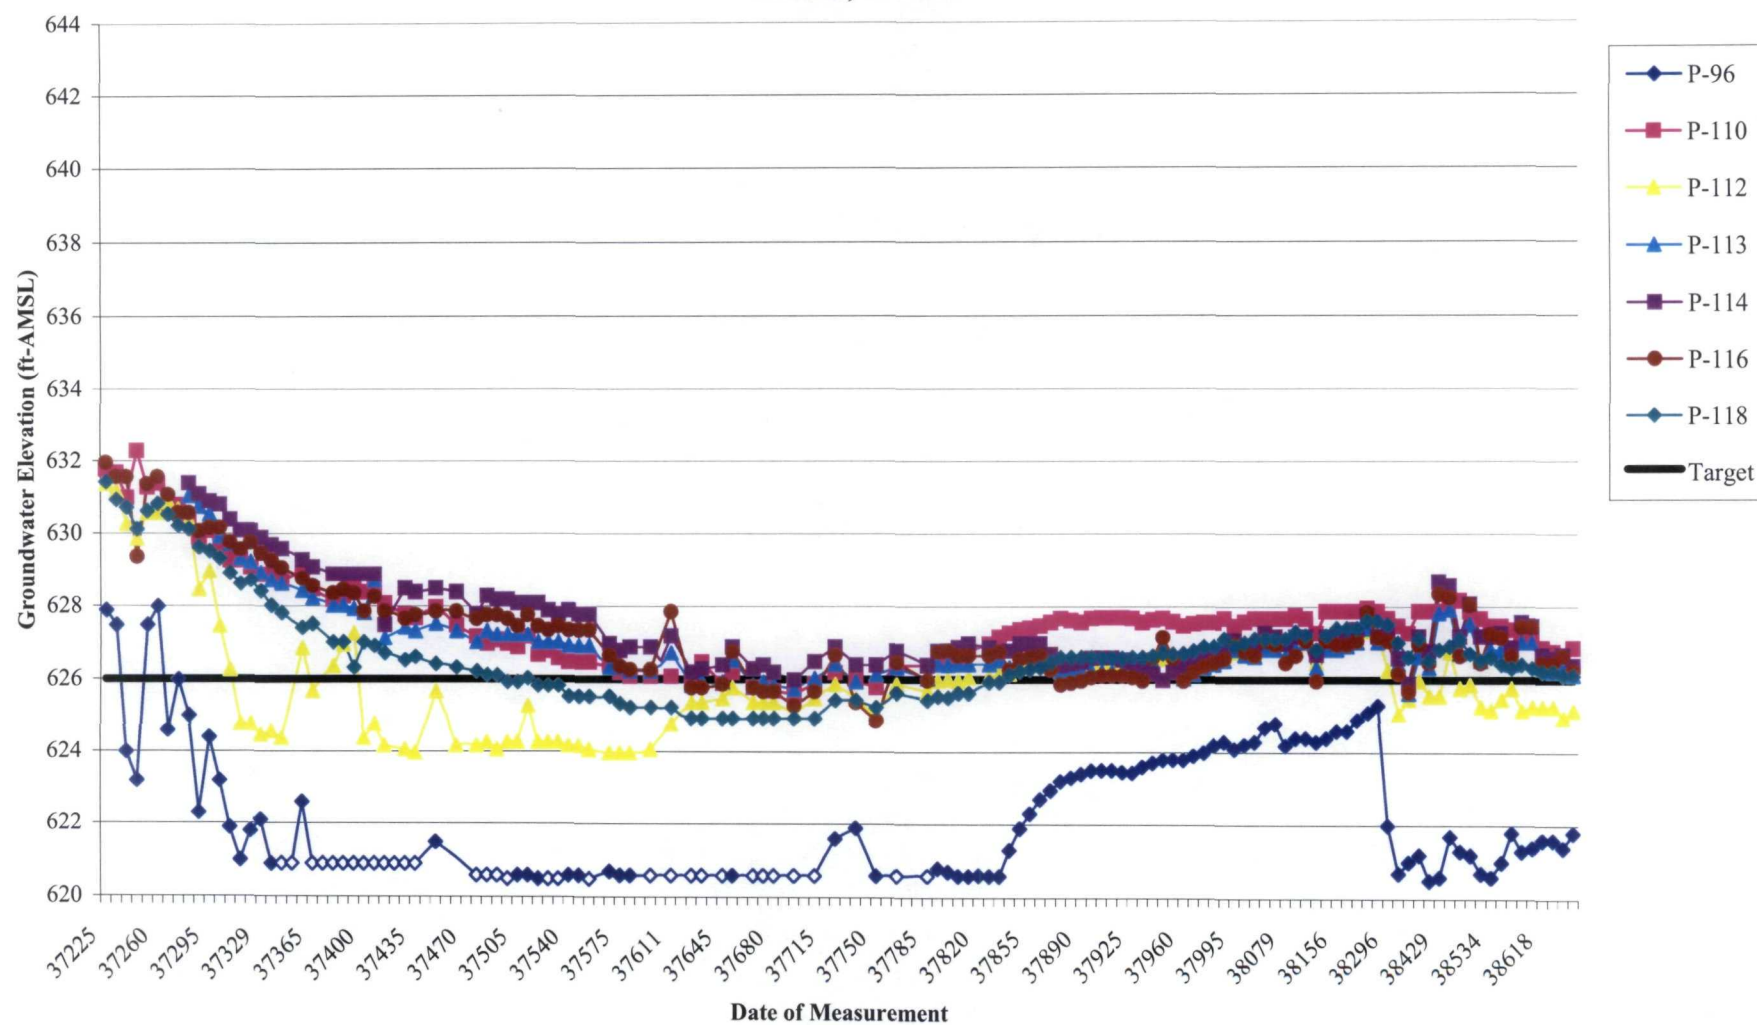
**Figure**  
**Off-Site Water Level Status - Piezometers**  
**Groundwater Monitoring**  
**ACS NPL Site**  
**Griffith, Indiana**

Hollow points represent dry piezometers

(data used for graphing purposes only). The bottom elevation of the piezometers may vary due to silting

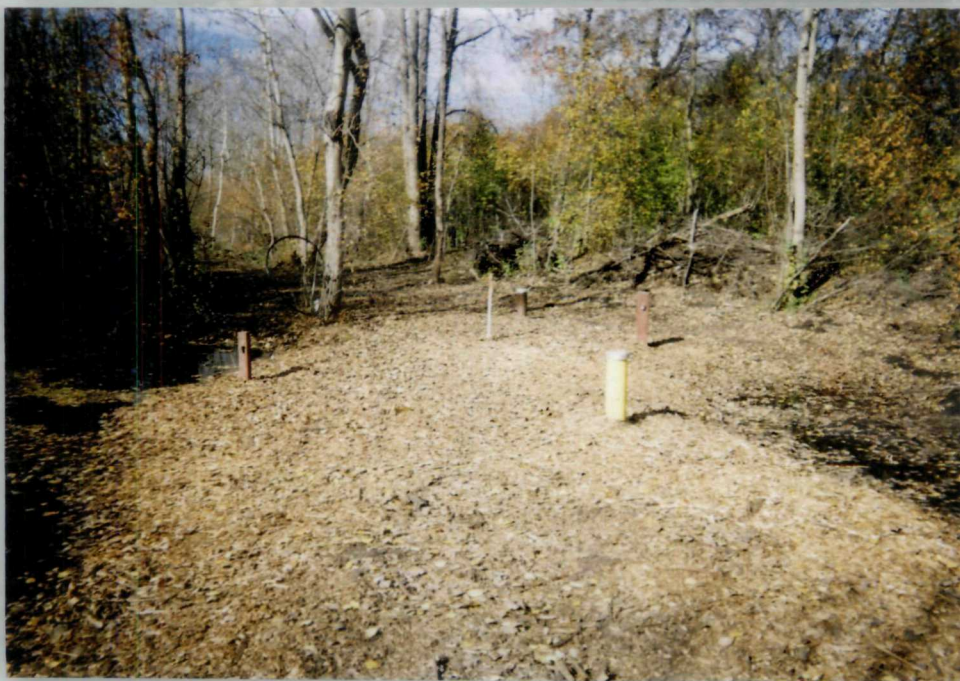
Site: American Chemical Service, Inc.  
 Proj. #: 44728 AES [46526 RAC]  
 Roll: 81 Photo #8  
 Date: 11-09-05 Time: 1112  
 Photographer: Larry Campbell  
 Description: Photo facing northwest showing EW02  
 pump test location after all gear has been  
 removed.

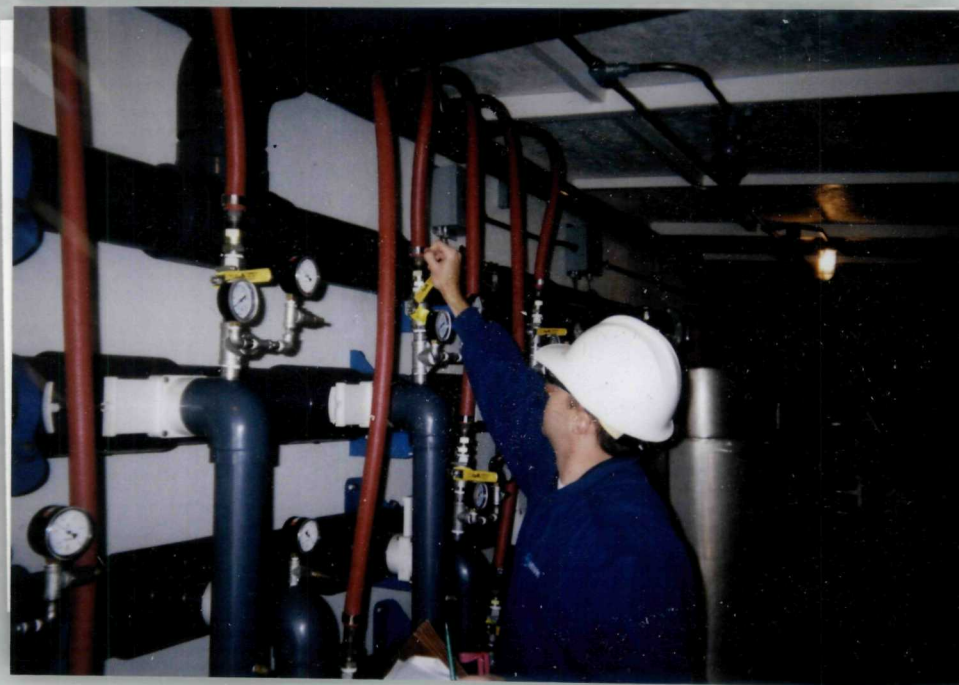
Site: American Chemical Service, Inc.  
 Proj. #: 44728 AES [46526 RAC]  
 Roll: 81 Photo #9  
 Date: 11-09-05 Time: 1135  
 Photographer: Larry Campbell  
 Description: Photo facing west inside SBPA ISVE  
 blower shed as selected wells are switched  
 from extraction (vacuum) to injection  
 (pressure).

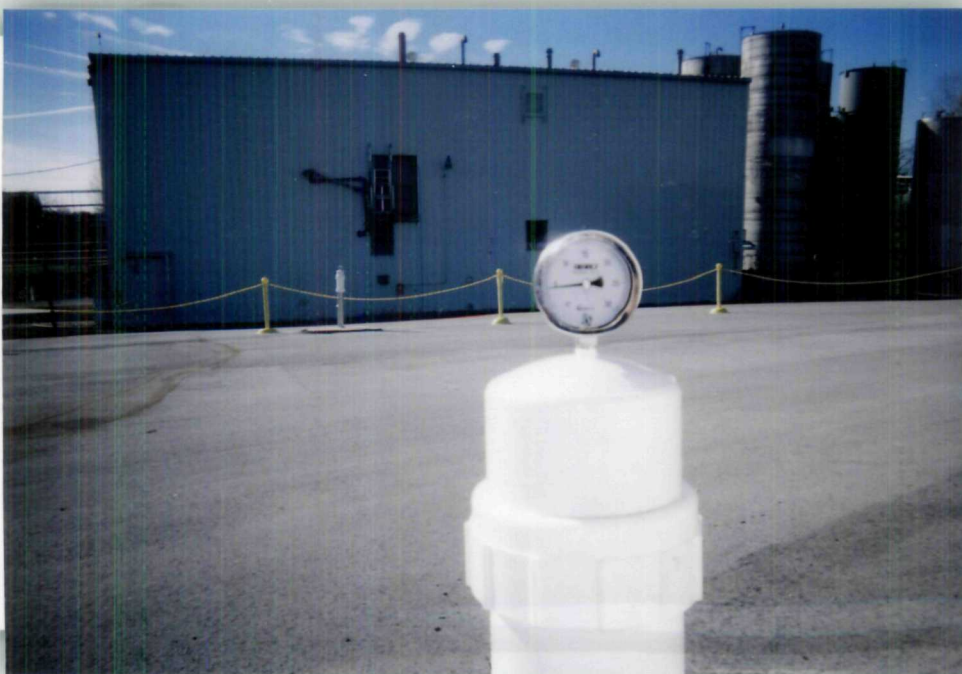
Site: American Chemical Service, Inc.  
 Proj. #: 44728 AES [46526 RAC]  
 Roll: 81 Photo #10  
 Date: 11-09-05 Time: 1140  
 Photographer: Larry Campbell  
 Description: Photo facing southwest showing pressure  
 gage on SVE 60 showing ~5 psi injection  
 pressure.

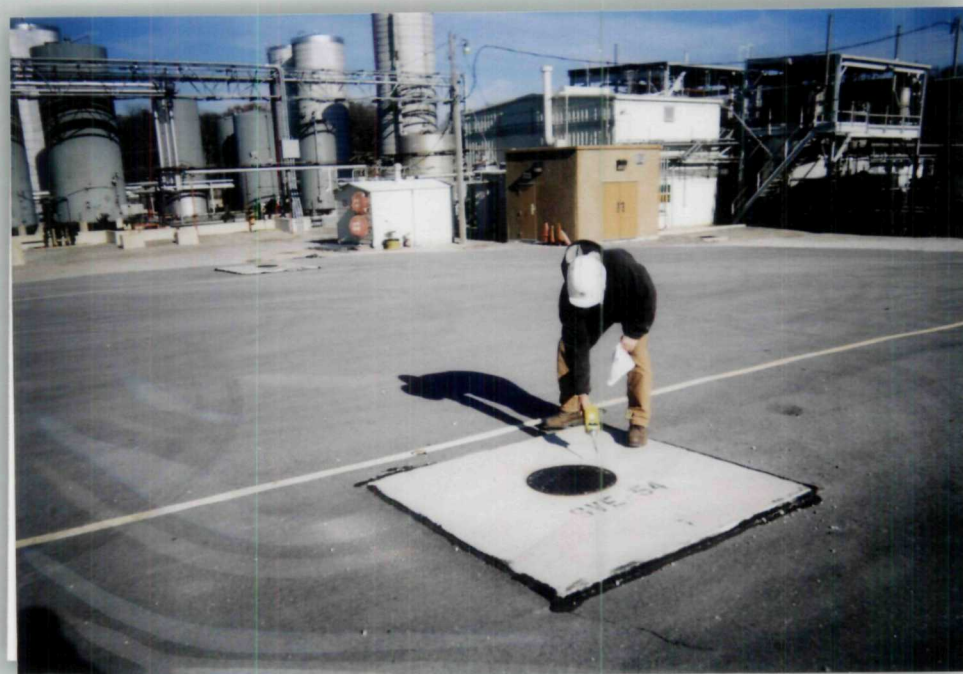
Site: American Chemical Service, Inc.  
 Proj. #: 44728 AES [46526 RAC]  
 Roll: 81 Photo #11  
 Date: 11-09-05 Time: 1330  
 Photographer: Larry Campbell  
 Description: Photo facing northeast showing MWH using  
 PID to check for VOCs at injection well  
 SVE 54.

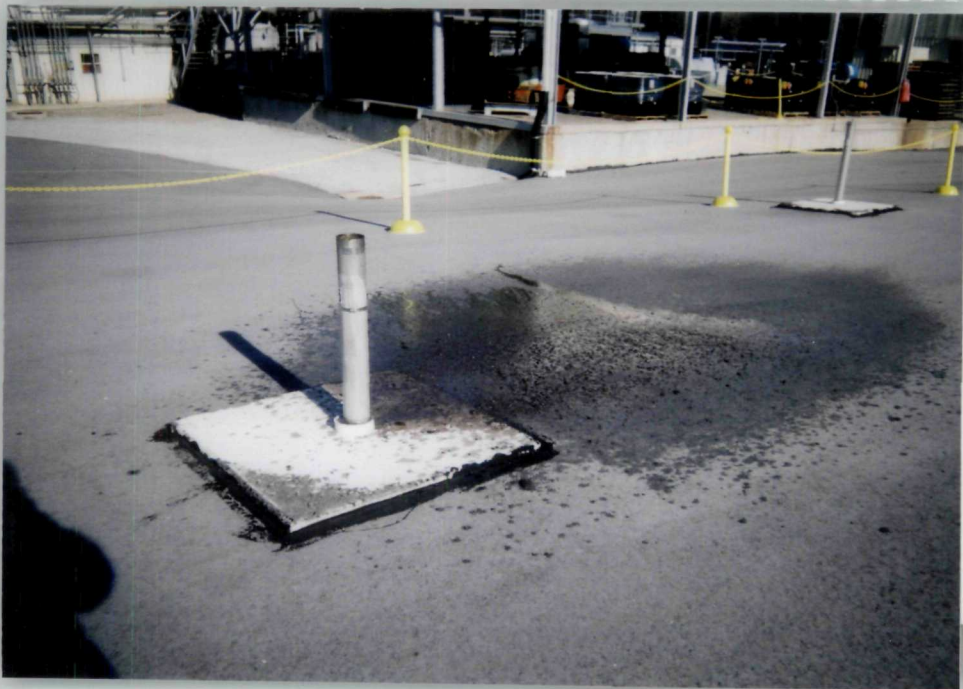
During the SBPA ISVE Upgrades startup testing on November 9<sup>th</sup>, caps at two ISVE wells popped off due to the pressure applied. For one of the wells, the cap was reattached and tightened and showed no further problems. When the well cap came off SVE-66, liquid sludge came out of the well and onto the SBPA cover. Less than a cup of the sludge ran into the drainage. The remaining sludge (less than a half a gallon) was collected and placed in the hazardous rollout box. The caps are rated for pressures up to 150 psi and the pressure applied during testing did not exceed 15 psi. To prevent a reoccurrence of this incident, the SVE well caps will be tightened using rope wrenches.

Site: American Chemical Service, Inc.  
 Proj. #: 44728 AES [46526 RAC]  
 Roll: 81 Photo #12  
 Date: 11-09-05 Time: 1332  
 Photographer: Larry Campbell  
 Description: Photo facing northeast showing SVE 66 after well top blew off when well was pressurized. Note water and product on surface after being blown from well.

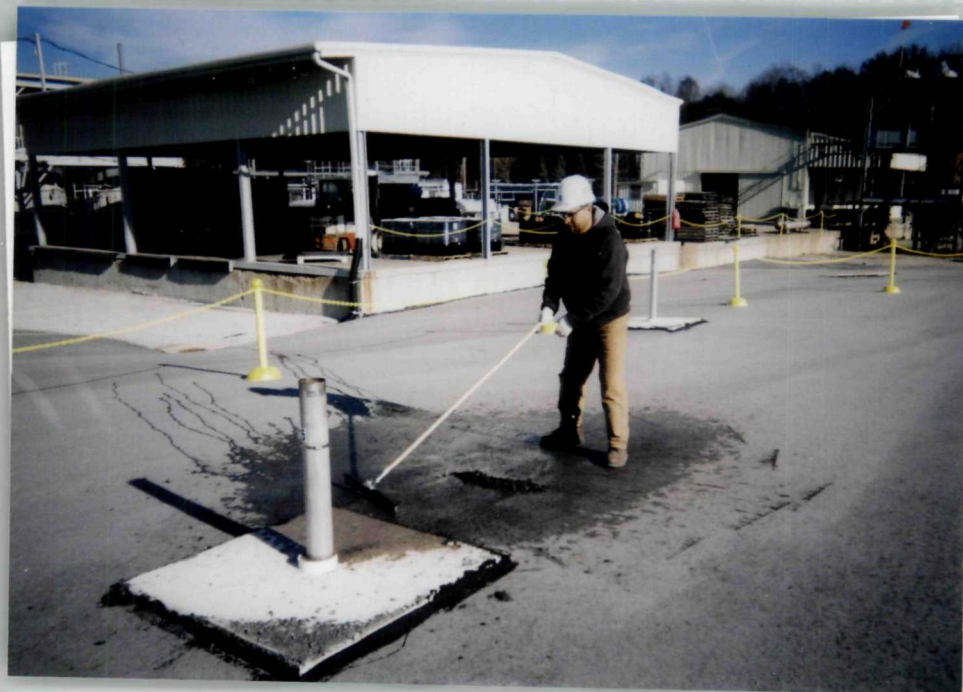
Site: American Chemical Service, Inc.  
 Proj. #: 44728 AES [46526 RAC]  
 Roll: 81 Photo #13  
 Date: 11-09-05 Time: 1344  
 Photographer: Larry Campbell  
 Description: Photo facing northeast showing MWH using squeegee to collect solids blown from SVE 66.

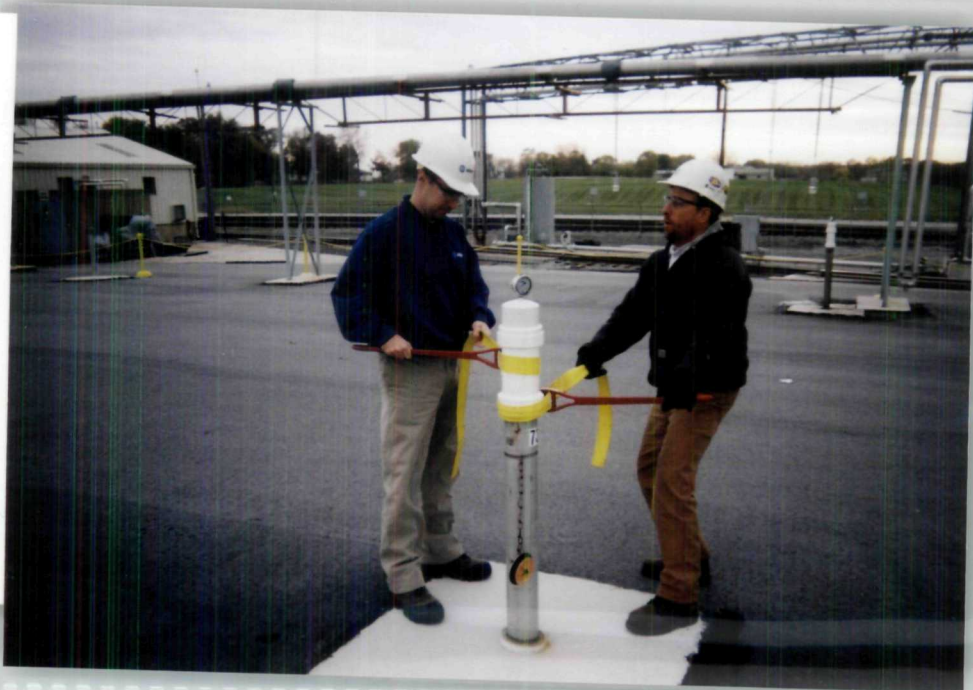
Roll: 81 Photo #14

Description: Photo facing southeast showing MWH  
 tightening couplings on well tops.

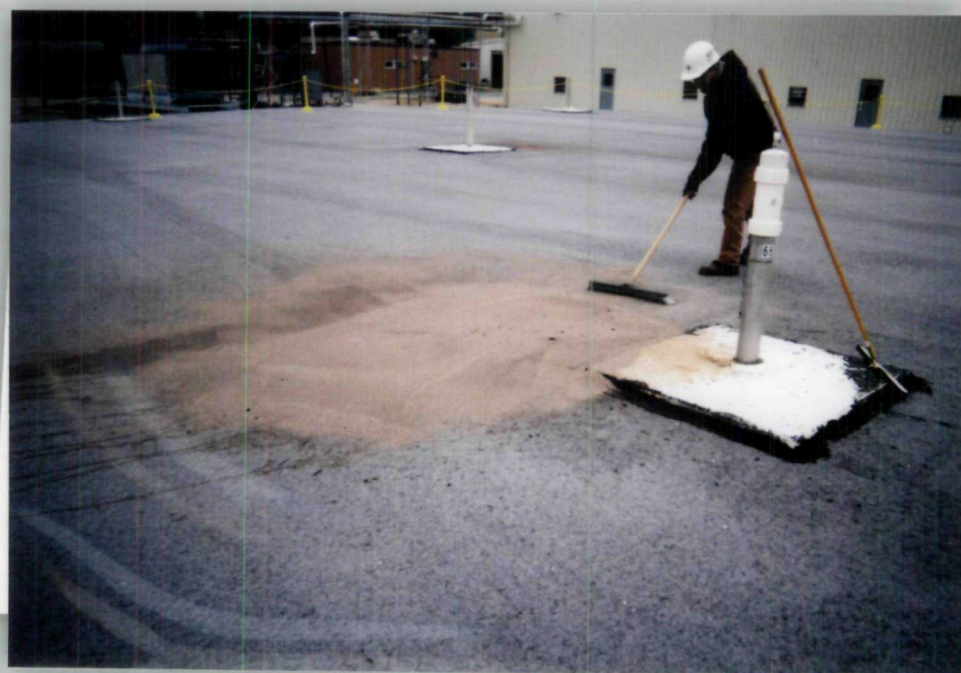
Roll: 81 Photo #15

Description: Photo facing southwest showing MWH  
 cleaning up spill with oil dry.

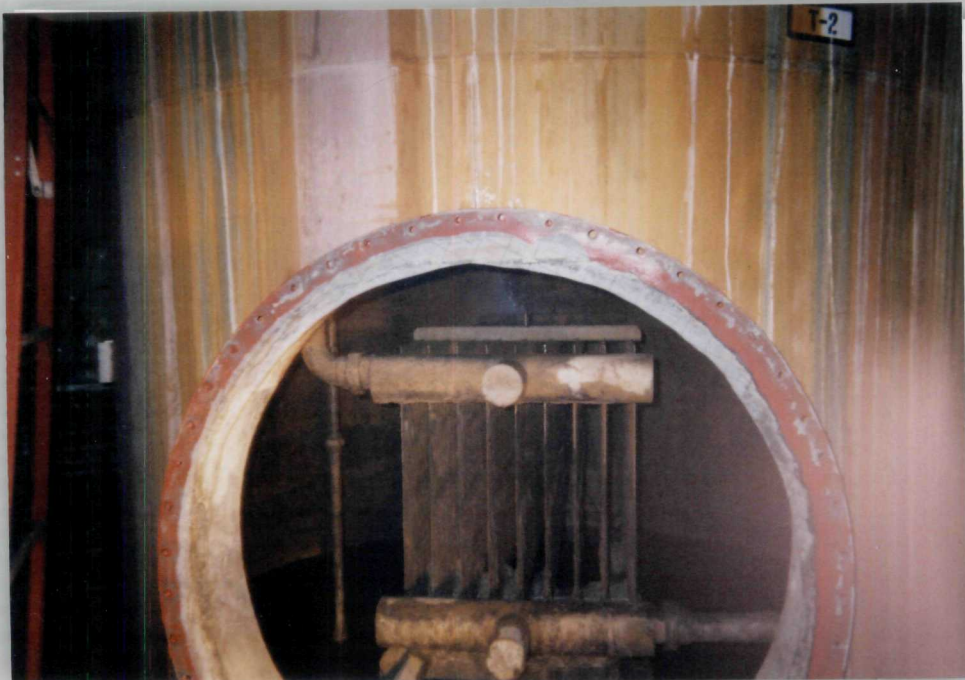
Description: Photo facing northwest looking into Tank T2 showing heat exchanger being cleaned out.

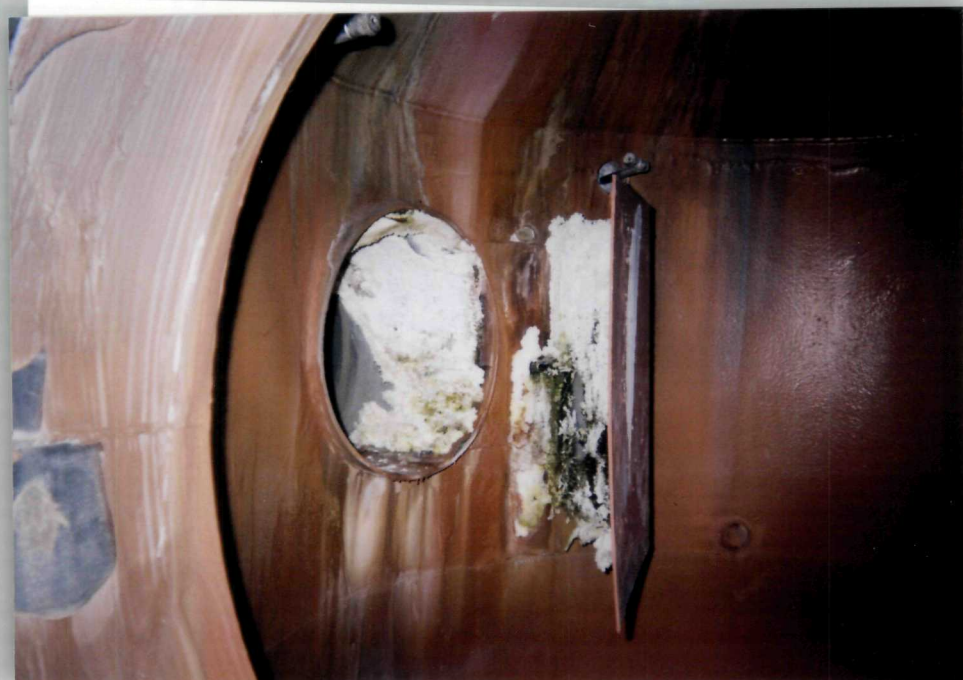
Description: Photo facing south looking into thermox 1 (ME 205B) showing air inlet and inlet deflector. Note white caked deposit on inlet and deflector.

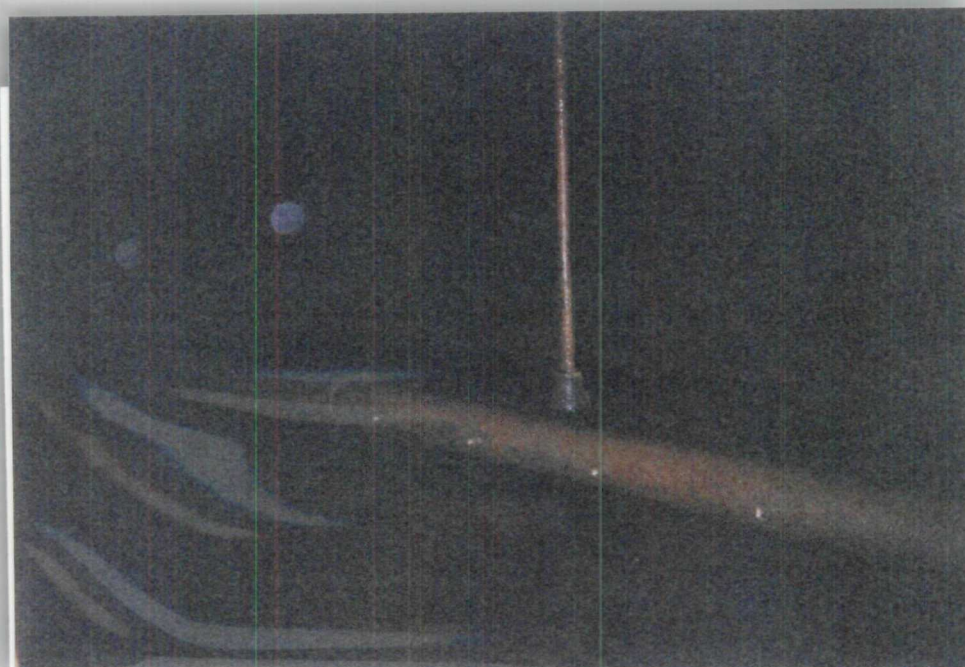
Roll: 81 Photo #18

Description: Photo facing south looking into thermox 1  
 showing damaged (peeling) rust colored  
 coating on interior of thermox 1.

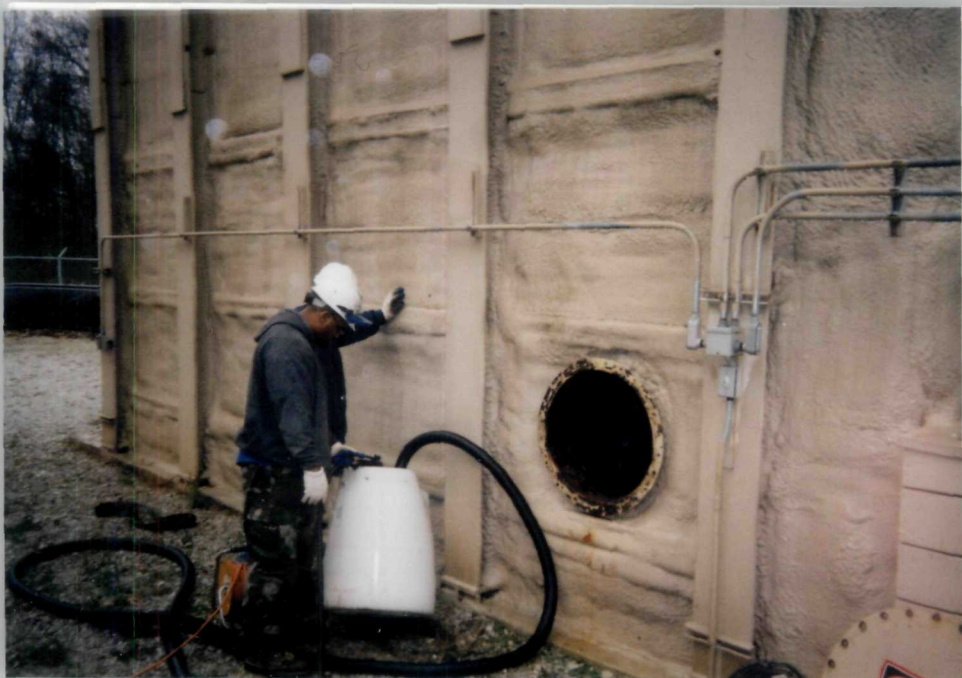
Site: American Chemical Service, Inc.  
 Proj. #: 44728 AES [46526 RAC]  
 Roll: 81 Photo #20  
 Date: 11-15-05 Time: 1058  
 Photographer: Larry Campbell  
 Description: Photo facing southwest showing IES  
 preparing to work on Equalization Tank  
 T102.

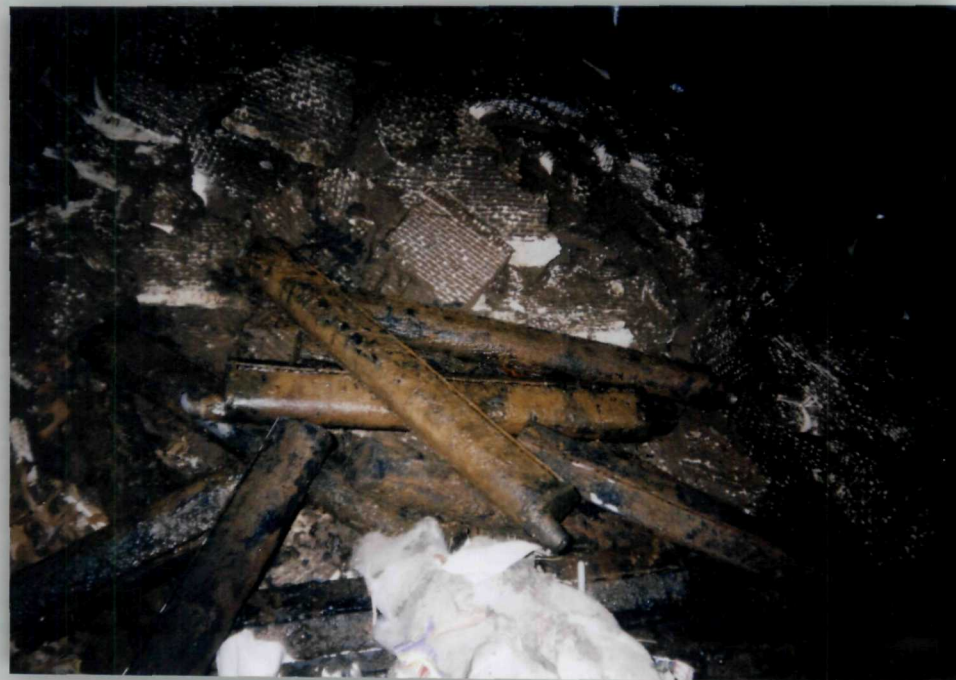
Site: American Chemical Service, Inc.  
 Proj. #: 44728 AES [46526 RAC]  
 Roll: 81 Photo #21  
 Date: 11-15-05 Time: 1103  
 Photographer: Larry Campbell  
 Description: Photo facing down into GWTP sludge roll-  
 off box showing discarded air diffusion arms  
 removed from Equalization Tank T102.
